HISTORIC STRUCTURE REPORT
Administrative, Historical and Architectural Data Sections
Seawall

FORT MCHENRY NATIONAL MONUMENT AND HISTORIC SHRINE
Maryland

Prepared by
Sharon A. Brown
and
Susan Long

August 1986

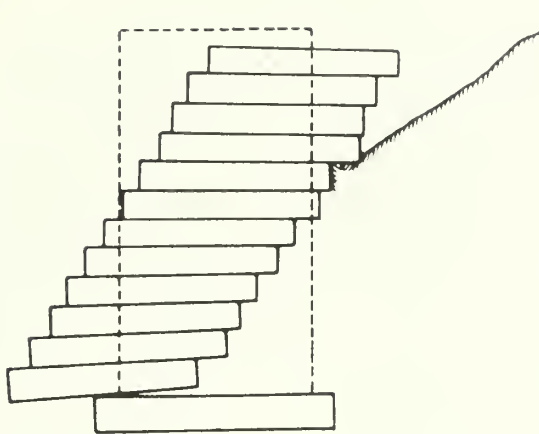
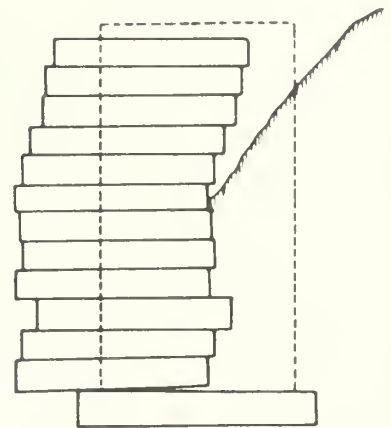
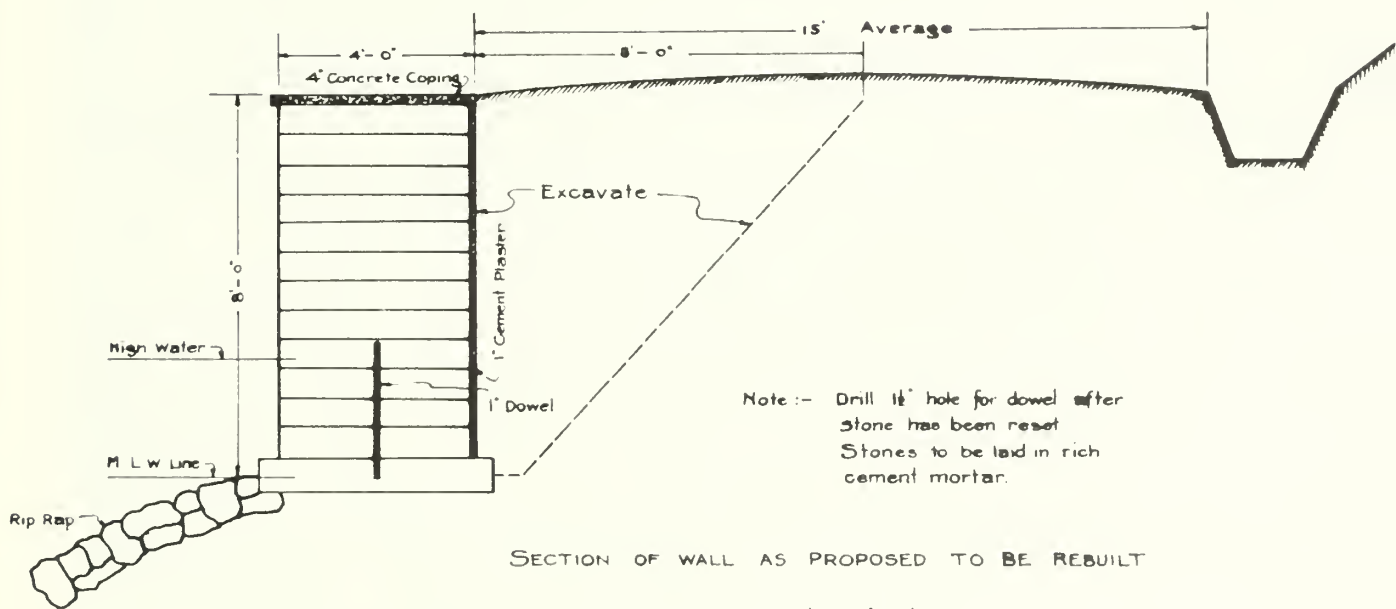
EXAMPLES OF PRESENT CONDITION OF WALL

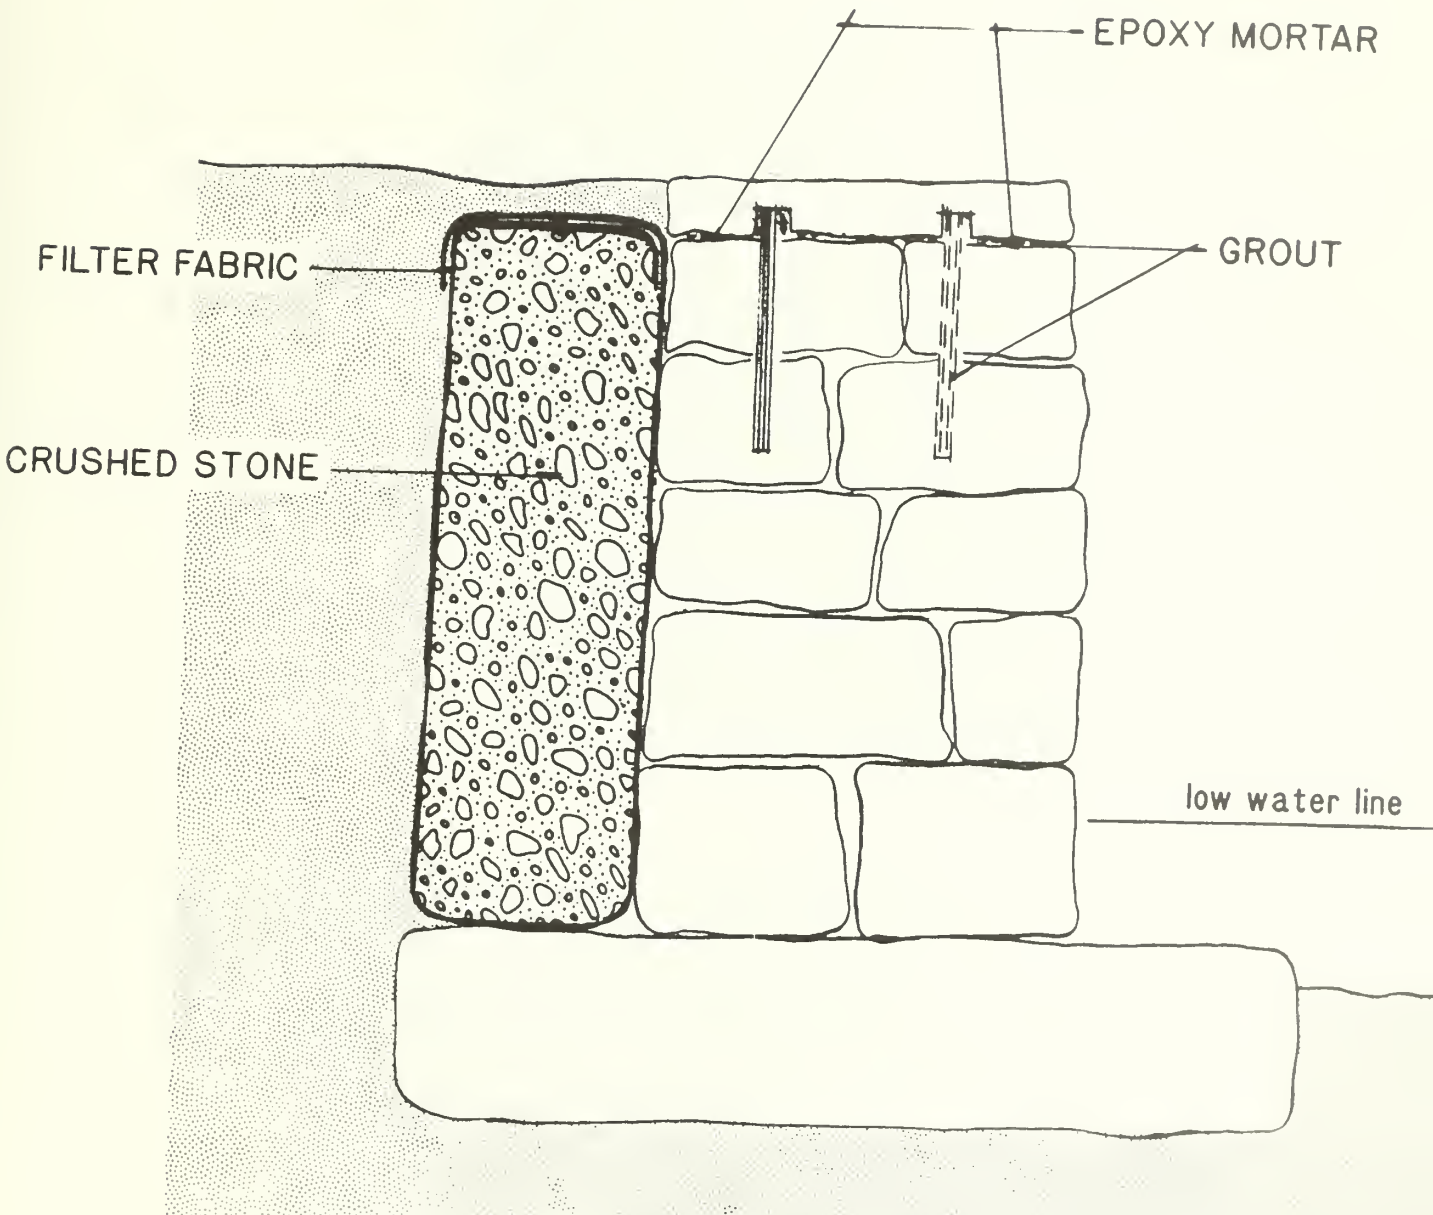
Figure 5: Rehabilitated wall section (typ.)

economical method of repairing the wall. Placing filter fabric and gravel behind the wall will stop the leaching of soil from behind the wall. Using epoxy and pinning the capstones in place will tie the wall together causing it to act as a massive unit as historically designed and prevent waves from moving the capstones. This is the method of stabilization recommended by the Corps of Engineers, Baltimore office, after physically inspecting the seawall (see figure 5).

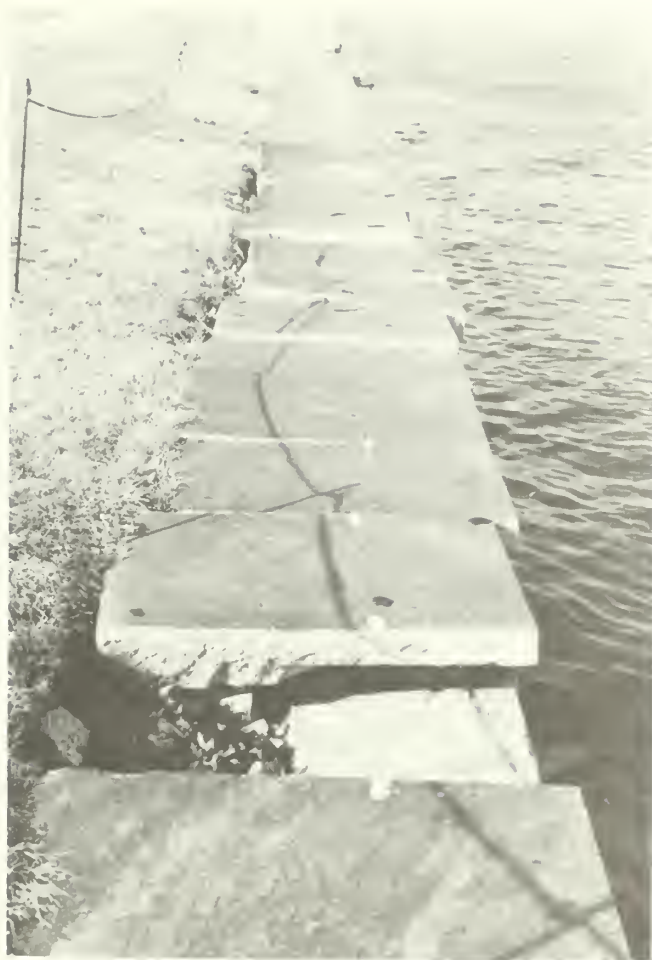
Photograph 4: Station 13 + 17.05 - Station 13 + 84.05.
Unraveled section of wall
